Technical Bulletin

Wheel Hub - CHA045

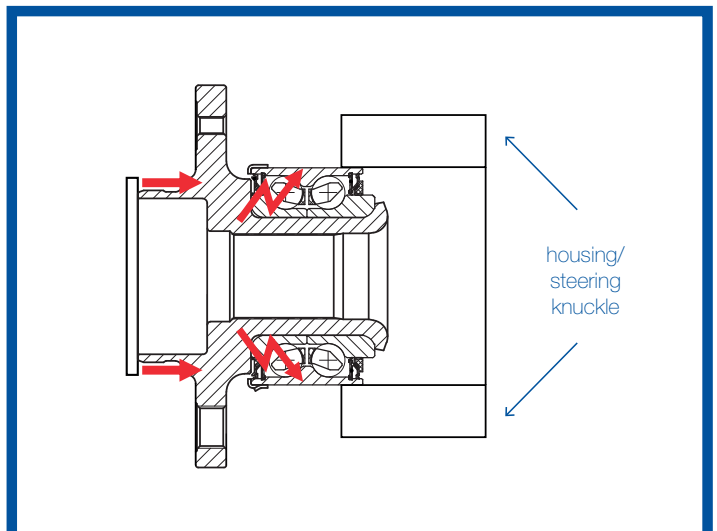
This shows incorrect installation process which leads to the problems mentioned above.
