Technical Bulletin

Installation Advice

Brake discs with ABS rings and sensors: A number of applications within the Comline brake disc range feature integrated ABS rings. Such designs are prevalent among Citroen & Peugeot vehicles, but there is a common fitment issue with this type of disc that relates the ABS ring and sensor.

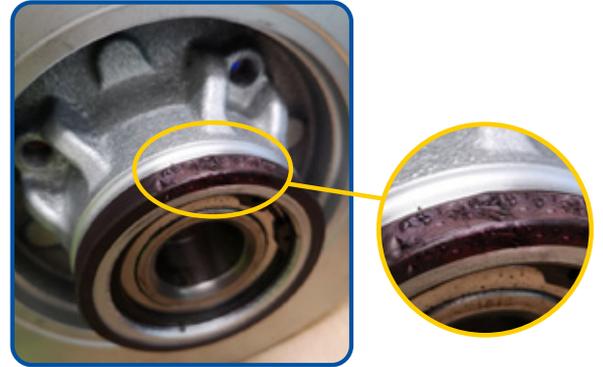
It may be possible to visually identify this problem prior to disassembly but there are some other symptoms to watch out for. The first is potential problems with the ABS system when fitting the new disc. Quite simply, if the ring and sensor are in direct contact, they will not function as intended or communicate with the vehicle's ABS system. In addition, the mis-located ABS sensor on the mounting point may have caused visible damage to the ABS ring on the disc being replaced. The image above illustrates the typical damage you should expect to see.

- 1 Remove the ABS sensor from the vehicle.**
- 2 Remove any corrosion from the sensor mounting point. If the sensor is installed within a guide tube, remove the sensor from the tube and remove any corrosion that is present.**
- 3 Check the ABS sensor for damage and replace if required. The original sensor can be safely re-installed if there are no visible signs of damage.**
- 4 Install the new brake disc ensuring correct air gap between ABS sensor and ABS ring.**
- 5 Check to ensure proper function of vehicle ABS system.**
