Technical Bulletin

Driving your brakes crazy!

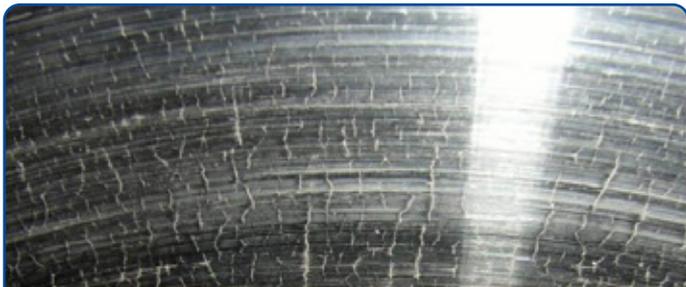
Brake disc “crazing”, sometimes known as “orange peeling” or “crazy paving” effect is when a cluster, or multiple clusters, of small, hairline cracks appear on the braking surface of the disc. These clusters can vary in size and should be relatively easy to spot, particularly if the vehicle features an open-style alloy wheel.

Such cracks are typically caused when the disc is exposed to high-temperatures and would potentially indicate that the motorist is working the brakes quite hard – quite literally driving their brakes “crazy”.

Close up of “crazing” on disc surface
