Technical Bulletin

Wheel Hub - CHA045

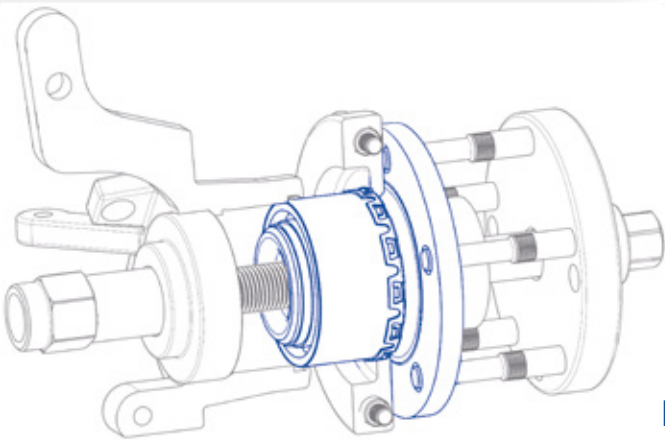
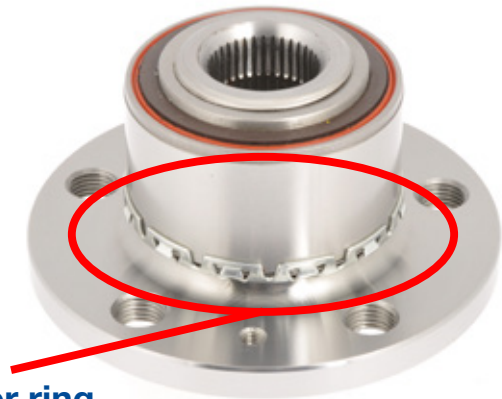
Metal outer ring

Incorrect installation will damage the bearing, leading to noise, excessive play and shortened service life.

The metal outer ring must be fitted correctly to the outer bearing face. The correct tool must be used in order to apply the load to the outer race of the bearing. See diagram below.

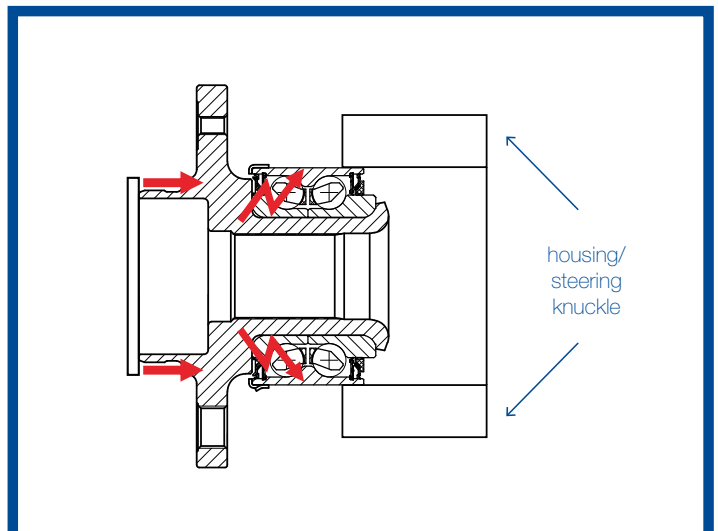
This shows incorrect installation process which leads to the problems mentioned above.
