Technical Bulletin

Installation Advice

Brake discs with ABS rings and sensors: A number of applications within the Comline brake disc range feature integrated ABS rings. Such designs are prevalent among Citroen & Peugeot vehicles, but there is a common fitment issue with this type of disc that relates the ABS ring and sensor.

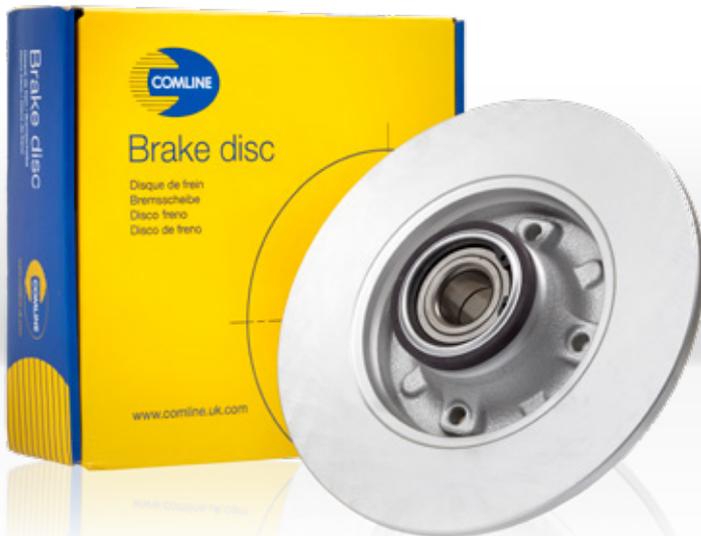
When correctly installed there is a defined 'air gap' between the ABS ring on the disc and the ABS sensor mounted to the vehicle. However, corrosion build-up on and around the mounting point can push the ABS sensor out of place. When installing a new disc, this removes the air gap and causes ABS ring and ABS sensor to touch.

It may be possible to visually identify this problem prior to disassembly but there are some other symptoms to watch out for. The first is potential problems with the ABS system when fitting the new disc. Quite simply, if the ring and sensor are in direct contact, they will not function as intended or communicate with the vehicle's ABS system. In addition, the mis-located ABS sensor on the mounting point may have caused visible damage to the ABS ring on the disc being replaced. The image above illustrates the typical damage you should expect to see.

- 1 Remove the ABS sensor from the vehicle.**
- 2 Remove any corrosion from the sensor mounting point. If the sensor is installed within a guide tube, remove the sensor from the tube and remove any corrosion that is present.**
- 3 Check the ABS sensor for damage and replace if required. The original sensor can be safely re-installed if there are no visible signs of damage.**
- 4 Install the new brake disc ensuring correct air gap between ABS sensor and ABS ring.**
- 5 Check to ensure proper function of vehicle ABS system.**
