Technical Bulletin

Driving your brakes crazy!

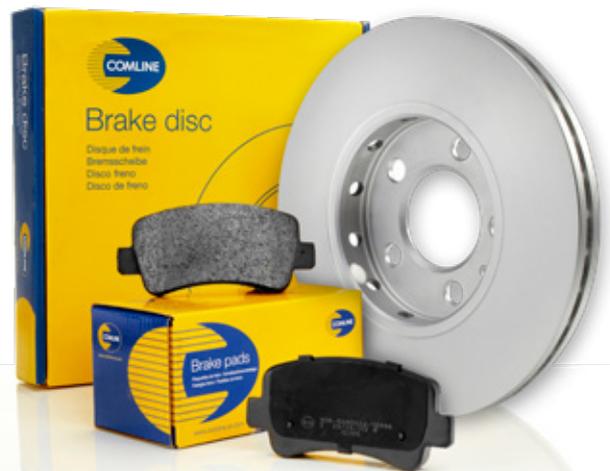
Such crazing can often present itself alongside the ‘blueing’ of the disc, whereby patches of the disc surface take on a blue tint – also a reaction to high braking temperatures. It is also possible to see disc blueing without crazing. Again, if in doubt, please consult a professional mechanic for their advice.
