Technical Bulletin

Issue 10017 – EFF147 Fuel Filter

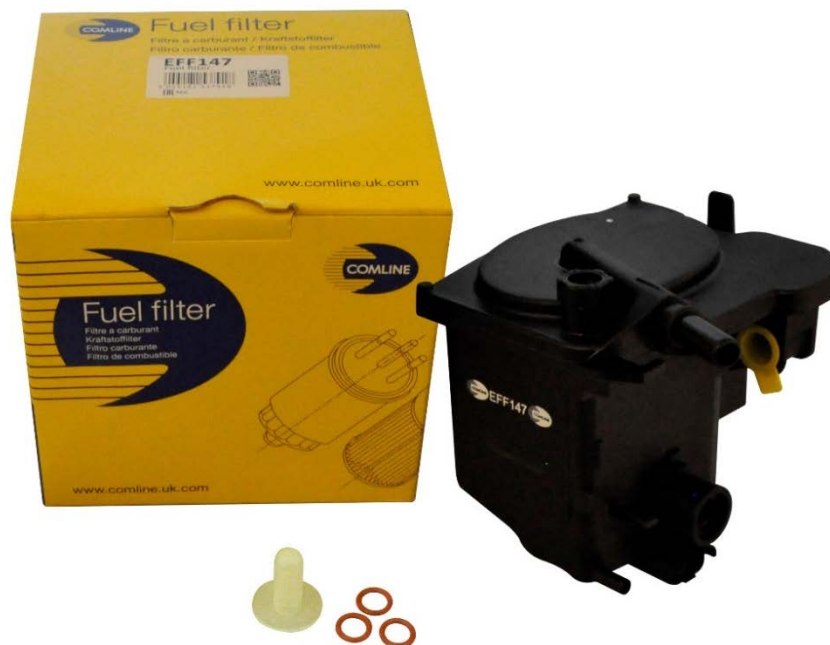
To combat common faults and fitment challenges that are prevalent with aftermarket variants of this fuel filter Comline has developed a number of vital features and built them into our version - [EFF147](#). These features are designed to deliver trouble-free installation and performance.

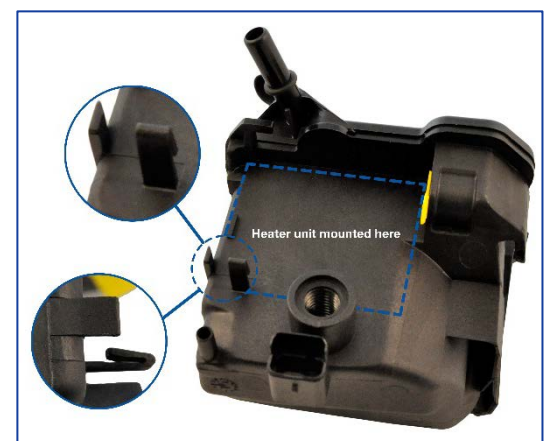
One of the most widespread faults with filters of this type is an issue with the mounting of the heater unit. Some examples of this filter fail to lock the heater unit securely in position, which can result in leakage due to an inadequate seal between the heater unit and the filter itself. Aware of such issues, Comline has adopted a dual-clip design on the EFF147 filter (opposite) designed to precisely locate the position of the heater unit for a solid, reliable seal.

When replacing this filter it is also essential to replace the O-rings on the heater unit. Failure to do so can result in a broken seal between the heater unit and filter, which in turn causes leakage.

Comline provide three replacement O-rings with each EFF147 filter.

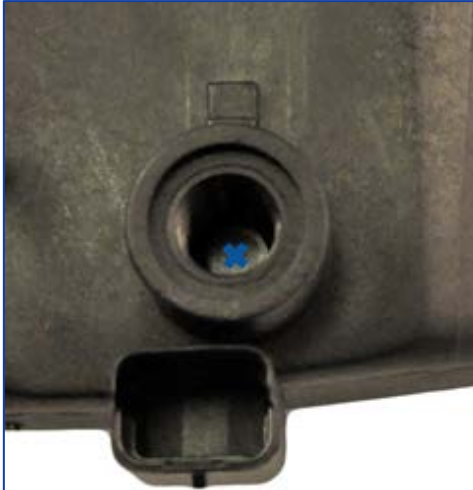
This particular filter carries a port for fitting a water level sensor; a feature that can cause some concern and confusion among technicians. The first point to note is that a water level sensor is not required on all vehicles and, in such cases, the port would simply remain unused.

In cases where the water level sensor is required the actual fitting process is very simple with the sensor simply screwing into the port. There is, however, considerable resistance when tightening the sensor followed by a very discernable 'crack'. This can cause concern for the technician, but both the resistance and the subsequent noise are by design. In simple terms, as the water sensor screws into position, the head of the sensor actually breaks through the dividing wall of the filter (left) putting the sensor in direct contact with the part of the filter where water accumulates.

The piece of the filter wall that breaks as part of this operation does not affect the performance or functionality of the filter.

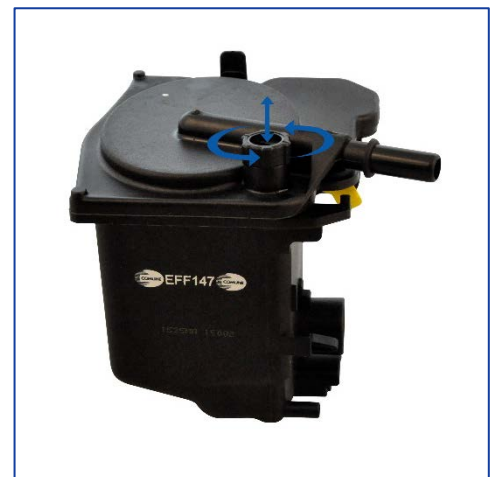
Care is needed to correctly drain water and bleed the filter to prevent a vacuum forming that would prevent fuel flow. For correct installation, the bleed/drain valve on EFF147 should be unscrewed after filter installation and immediately closed as soon as fuel begins to flow. To ensure the correct procedure is followed Comline provides full fitting instructions with each EFF147 unit.

EFF147 features a single, dual-purpose bleed/drain valve (right) manufactured with high-quality PP materials to prevent damage or twisting during valve operation. In addition, the valve screw cannot be fully unscrewed and removed from the filter. This feature not only reduces the likelihood of cross-threading the valve screw, but also negates the possibility of losing a critical component during filter installation.
